WEEKLY PROJECT REPORT

Ekushey Bhaban-Superstructure-Progress

Project: Ekushey Bhaban - Superstruc
Date: 24/08/11

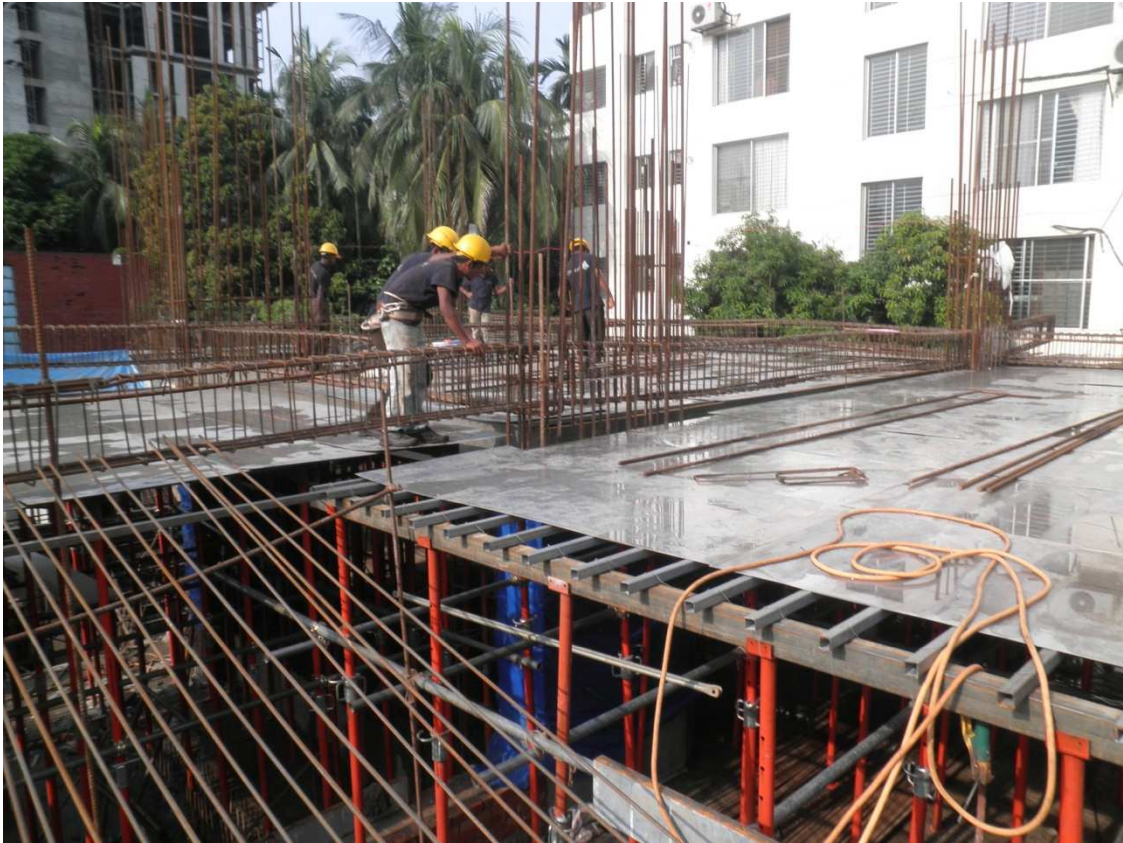
Photograph taken 20 Aug 2011 03:58 PM (Photograph on 18 Aug not available)

- Honey comb observed after opening shutter which should be minimized
- In order to proper project monitoring a Planning Engineer cum Quantity Surveyor should be appointed to take required photographs, keeping records and communicate with Consultant.

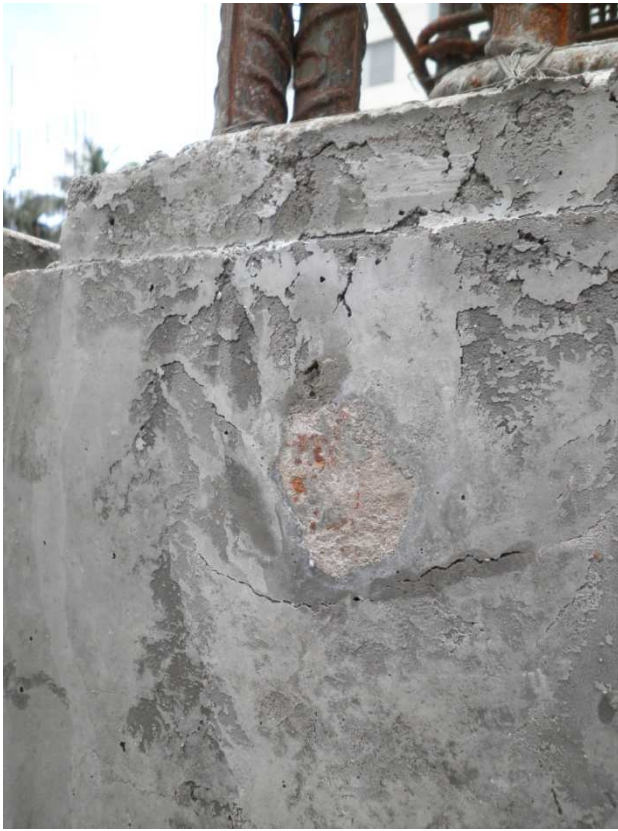
Photographs taken : 03 August 2011 12:10 PM

- 1) Some air bubble found in concrete of second lift of column, but we are trying to recover it.
- 2) Continuous monitoring of concrete quality in site by established check list and procedure and in plant is done in this week.

1. Honeycomb observed after opening of column shutter (Photographs attached). This is due to following Reasons:

- a) Concreting after expiring setting time due to shortage of Concreting labour.
- b) Lack of supervision - Not vibrating or wooden hammering .

HONEY COMB OBSERVED
AFTER OPENING SHUTTER

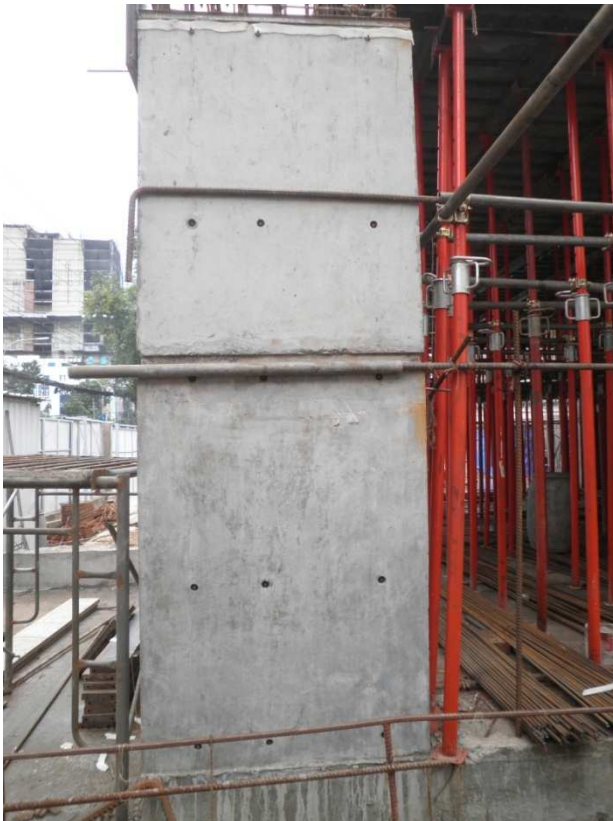
Photographs taken : 23 August 2011 01:58 PM

AFTER REPAIRING

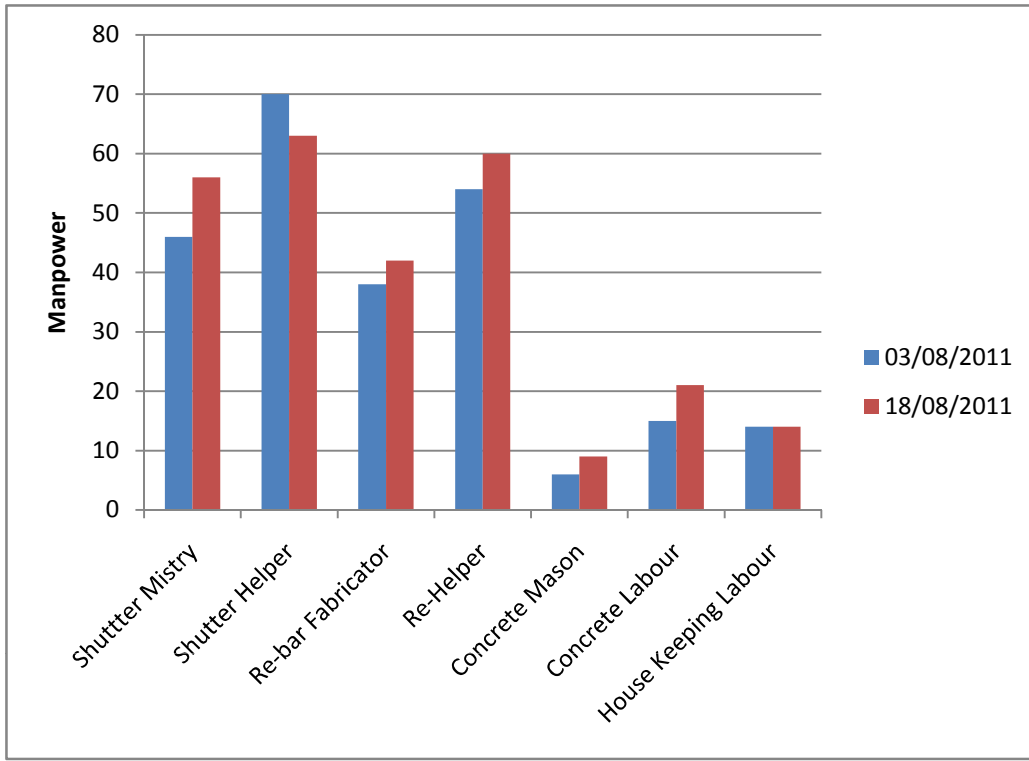
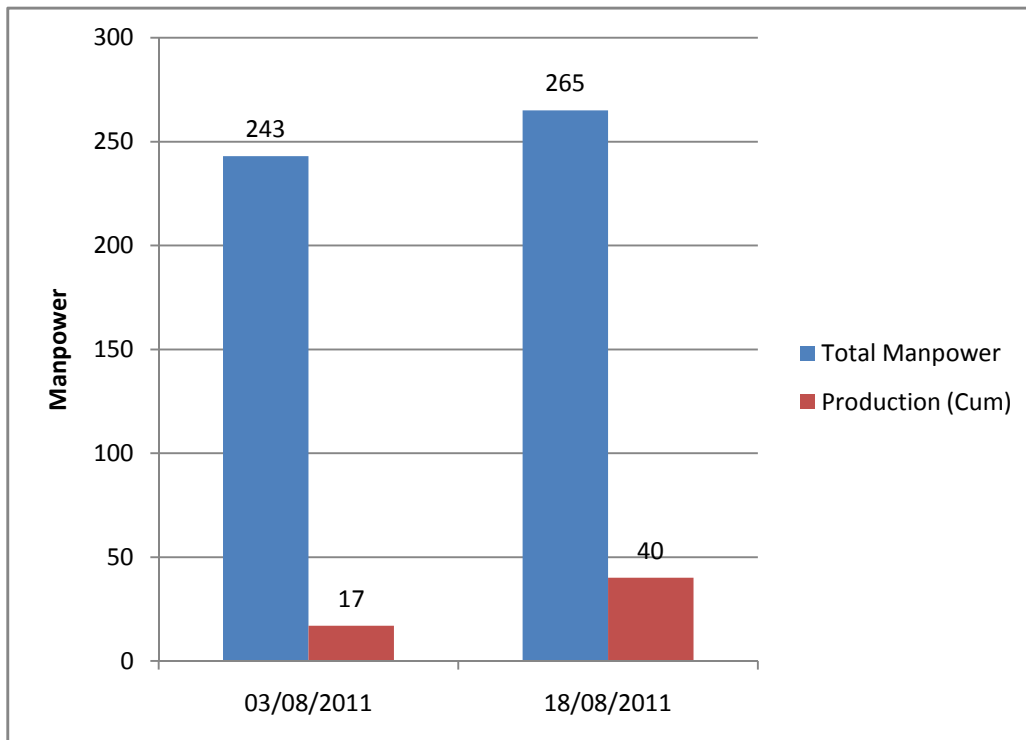
MANPOWER HISTOGRAM

1. Labour is increased 22 (9%) from 2-week before. Now 265 per week.
2. Manpower Histogram attached
_____ Consultant
_____ Chief Engineer
